PREPARED FOR SAFETY RESEARCH & STRATEGIES, INC.

Toyota Electronic Throttle Control Investigation

Preliminary Report

2/21/2010

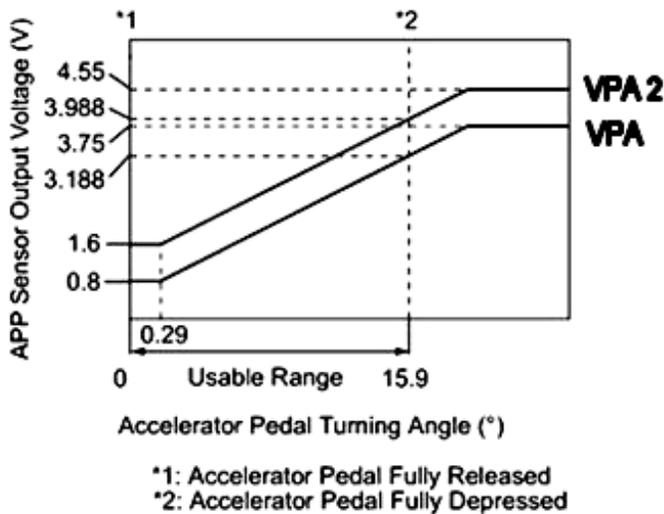
Normal Toyota APP

angle and is used for engine control” (Appendix: TIS Service Document, p. 1). Voltage limits for VPA, range from 0.4 to 4.8 Volts or more. The signal from VPA2 (sub) “conveys the status of the circuit and is used to check the APP sensor itself” (Appendix: TIS Service Document, p. 1). Voltage limits for VPA2, range from 1.2 to 4.8 Volts or more. Of important note, are the *overlapping* voltage values of the two APP signal inputs to the ECM.

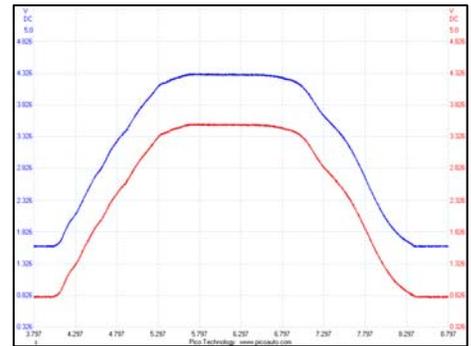
Potential Loss of APP Sensor Redundancy

Because their important role to accurately convey vehicle driver demands for throttle opening, APP sensor voltage inputs should always be confirmable by the ECM as absolutely correct. It was noted in the service literature that the threshold limits for a voltage difference of “0.02 Volts or less” between the two APP signal circuits should set a DTC P2138 (Appendix: TIS Document, p. 3). This voltage appeared to be an unusually close threshold value for a short between circuits. In other words, these two signal voltages could have been *almost* identical, and remain safely within the parameters of the P2138 DTC threshold limits. The VPA and VPA2 normally operate through a common range of parallel planes of voltage values. In addition, the two signal voltage values are normally supposed to rise and fall in unison with each other. If the two signal voltages

were in some fashion to become interconnected (shorted) through a certain amount of circuit resistance, the lower VPA voltage could be pulled up slightly in value. The higher VPA2 voltage could be affected in the opposite manner and pulled down slightly in value. At the same time, both sensors could conceivably stay within the upper voltage boundary of 4.8 Volts or more for the P2123 and P2128 DTC criteria. Similarly, the VPA2 1.2 Volt low threshold limit value for a P2127 DTC would not be reached, and the VPA 0.4 Volt low threshold limit value for a P2122 DTC would not be reached. Signal interconnection through resistance could then potentially tie the two circuits together without setting a DTC. At that point, APP signal circuit redundancy is lost and neither signal circuit is verifiable by the ECM as defective. The ECM will only react to defective voltages outside of the range of programmed limitations-so if the circuit is not defective; it must be good. Without a DTC set, the ECM will not logically enter into a fail-safe mode of operation.

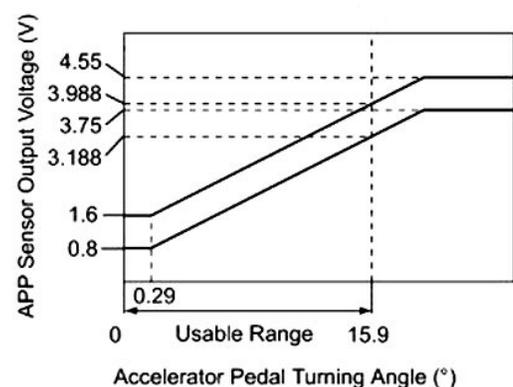
In review of the TIS service information, collected vehicle data, and performance observations; some general assumptions can be drawn from the research completed to date. The inability of the Toyota ECM to detect certain types of short circuit malfunctions could fall back to the basic design of the normal APP signal voltage limitations. The parameters for APP signal short circuit fault detection are apparently too lenient. In the Toyota ETC system, the APP sensor signal voltages rise simultaneously in direct response to accelerator pedal depression. With this design, interconnected signal circuits could be more difficult to identify with a circuit fault detection strategy that uses only threshold voltage limitations.

A more conclusive circuit fault detection strategy could use APP signal voltages (see A & B) that have rising slope, but with offset voltages that increase at slightly different rates. Several vehicle manufacturers currently use this fault detection strategy for APP sensor signal circuits.

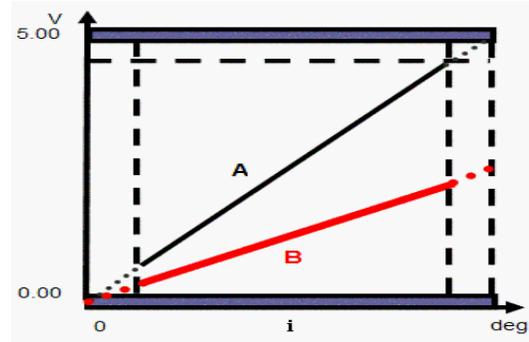
The obvious advantage, of using two different angles of increasing voltages from the APP signal circuits, is that the signal voltages are never consistently rising at the same rate. In this design, short circuit connections between the two APP signal circuits would ultimately be detected by the ECM because the signal voltages should never increase at the same rate or angle.
