PREPARED FOR SAFETY RESEARCH & STRATEGIES, INC.

Toyota Electronic Throttle Control Investigation

Preliminary Report

2/21/2010

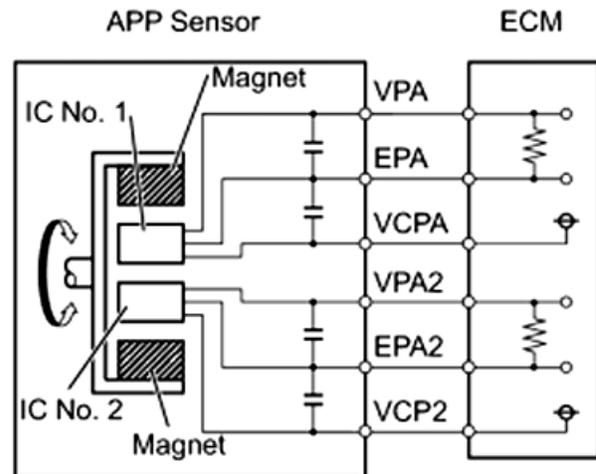
APP Sensor Circuit

Of particular interest were the APP signal inputs to the ECM. According to the Toyota TIS service information, the APP sensor is a non-contact type that uses two independent Hall-effect elements. As described, the APP sensor will have two completely separate sensing circuits: Voltage Pedal Accelerator (VPA), and Voltage Pedal Accelerator 2 (VPA2). Each sensing circuit will have a separate voltage supply circuit (Voltage Constant Pedal, or VCP), a separate ground circuit (Earth Pedal Angle, or EPA), and separate signal circuits (VPA and VPA2). The ETC system description further defines the two signal circuits as VPA (main) and VPA2 (sub). As TIS describes the circuit, the signal from VPA (main) “indicates the actual accelerator pedal opening

angle and is used for engine control” (Appendix: TIS Service Document, p. 1). Voltage limits for VPA, range from 0.4 to 4.8 Volts or more. The signal from VPA2 (sub) “conveys the status of the circuit and is used to check the APP sensor itself” (Appendix: TIS Service Document, p. 1). Voltage limits for VPA2, range from 1.2 to 4.8 Volts or more. Of important note, are the *overlapping* voltage values of the two APP signal inputs to the ECM.

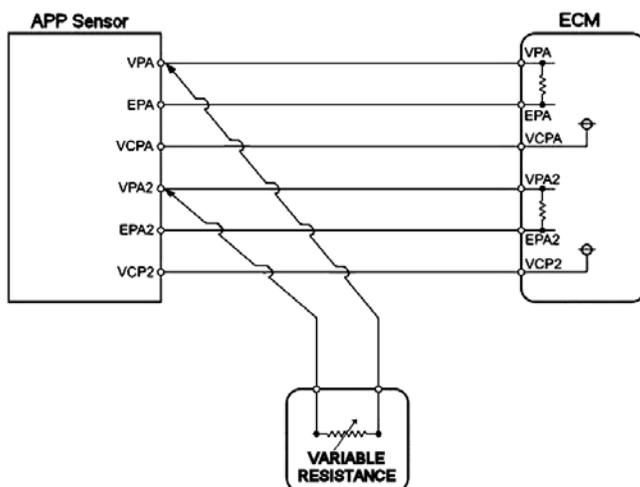
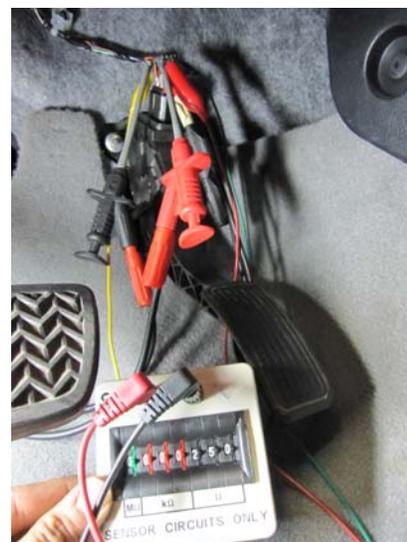
Validation testing began with DTC P2138, which is intended to detect abnormal conditions concerning the APP sensor, the ECM, and short circuits between VPA and VPA2 circuits. While monitoring APP signal voltages with the ignition “Key ON-Engine OFF” (KOEO), various resistances between the two APP signal circuits were introduced for trial. The effects of the different resistance values were recorded to determine the ECM’s actual circuit detection capabilities for this type of circuit malfunction. Ample time duration of “2.0 seconds or more” was allowed, as listed in the service literature for one trip detection logic. MIL illumination was used to signal the presence of ECM fault detection and subsequent DTC storage. It was soon realized that certain short circuit resistances between VPA and VPA2 were undetectable by the ECM. Once initial fault limitations were roughly established, “Key ON-Engine Running”(KOER) trials were conducted with similar fault detection procedures. Of particular interest was vehicle engine operation within the ECM acceptable voltage zone of a compromised VPA to VPA2 circuit short. The test vehicles generally ran well, in spite of the simulated signal circuit malfunction.

With the two APP sensor signals shorted together through a varying range of resistances, all four Toyota vehicles reacted similarly and were unable to detect the purposely induced abnormality. The types of signal faults introduced into the APP circuit should have triggered the vehicles' ECM to illuminate a MIL within seconds. The ECM should have then set a DTC, entered the vehicle "fail-safe" mode, and reduced engine speed and/or power. When the two APP signal circuits are shorted together, the redundancy of the APP circuit design is effectively nullified and lost. In other words, neither of the shorted APP signal circuits can be verified by the ECM as either; correct or incorrect. The condition then exists for a serious concern for driver safety. In the tested Toyota ETC vehicles, incorrect or corrupted APP sensor signal inputs could potentially result in unwanted engine speeds. Additional research should be done to determine if other vehicle manufacturers may have similar inconsistencies in ETC circuit fault detection.

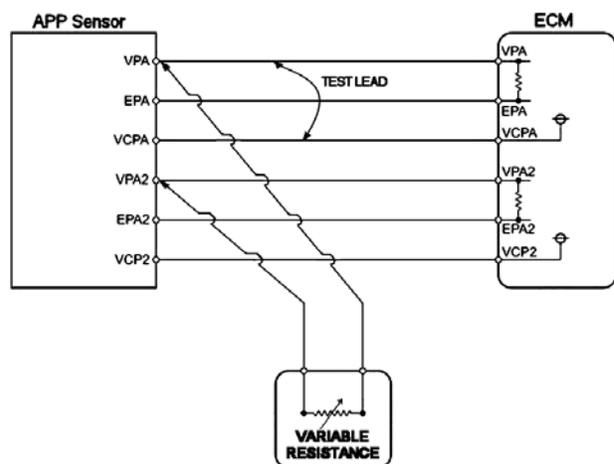
While running the engine in a VPA to VPA2 short circuit state, without MIL illumination or stored DTCs, accelerator pedal response rate and range was noted. Accelerator pedal observations were made with simultaneous brake pedal application, and without simultaneous brake pedal application. Recorded data, observations, and results were listed in detail for each specific test vehicle. To further test the absence of fault detection, experimentation was done to determine if the ECM would set a DTC with a combination of additional circuit abnormalities. Two combination tests were performed to include VPA and VPA2 shorted together (operating undetected), and circuit continuity to ground and power. The VPA and VPA2 signals operating in a short circuit state (undetected by the ECM)

were given a circuit path to EPA AND EPA2 (ground). Additionally, the shorted VPA and VPA2 signal circuits (undetected by the ECM) were tested with a circuit path to the VCPA and VCP2 (5 Volt supply). These tests were made during both: KOEO, and KOER conditions. Several different combinations of trials were made before discovering that when VPA and VPA2 were shorted together, with an undetectable resistance, and a connection was made from either VCPA or VCP2 to the VPA2 circuit *only* – both VPA voltages would rise together in unison. As a direct result of the connection to the VCP 5 volt supply circuit, the ECM responded by opening the engine’s throttle. Surprisingly, the ECM was repeatedly unable to detect this serious circuit fault abnormality. The vehicle showed no MIL illumination nor stored DTC in the ECM. Most alarming during KOER trials, the engine speed increased almost instantaneously to the full operating RPM limits of the engine. The resulting condition was also present with or without brake pedal application.

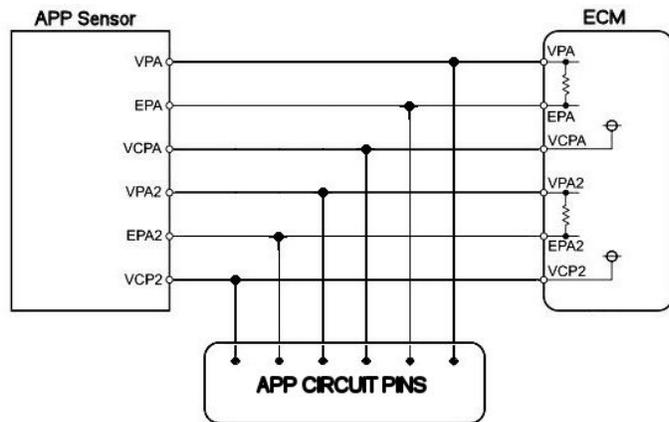
taps was to provide more secure and stable connections to the APP circuitry. By providing more accessible and manageable “pin-out” connections of the APP circuits, testing methods were enhanced with more reliable voltage and resistance measurements. Plus, secure and clearly labeled circuit connections

provided for a much safer laboratory testing environment. Evaluation tests were now more narrowly focused on the capabilities of the ECM to detect fault conditions to set a DTC P2138. DTC P2138 is the code used to detect the presence of a short between VPA and VPA2 signal circuits. Resistance values for shorted VPA and VPA2 signal circuits,

Using shorted APP signal circuit fault conditions purposely installed on the test vehicles, and with known resistance values that would not set a DTC, vehicle operational behaviors were also noted. It was observed that all test vehicles could be operated without the ECM detecting the induced malfunction. Depending on the resistance value of the APP signal circuit fault, a vehicle may or *may not* experience noticeable changes in accelerator pedal operational behavior. Observed accelerator pedal operational characteristics included: normal response, sluggish response, and travel with inconsistent engine speeds. It is conceivable that a driver of an ETC vehicle may not appreciatively notice that an APP sensor and/or circuit malfunction currently exists. Without the aid of an illuminated MIL, a driver could be unaware of electrical problems within the ETC system. In addition, the shorted APP signal circuits were connected momentarily to the sensor's 5 Volt supply circuit with the vehicle in drive. In all test vehicles, the ECM did not set a DTC and the engine speed increased rapidly to full throttle. This result shows that unusual or sudden unintended acceleration of the vehicle was possible in the ETC test vehicles. It should be noted that in all test vehicle cases, the electronic throttle valve *instantaneously* moved to wide-open position when the fault was introduced. More research should be done to determine the extent of Toyota ETC vehicles that could be affected by this condition.
